# **ARCHITECTURAL AND ARCHAEOLOGICAL STUDIES AT ILE DE LA PASSE**

## **MAURITIUS**

**The 2003 Season  
January-February 2003**

**A Report Submitted to Sponsors**

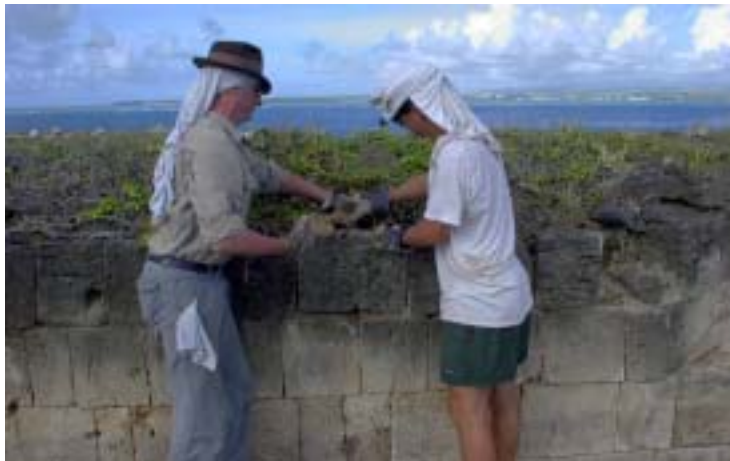
*Conservation First Aid... Bradley and Jonathan pushing back into position the displaced stone seen at center left in the previous photo. (03jv1304)*

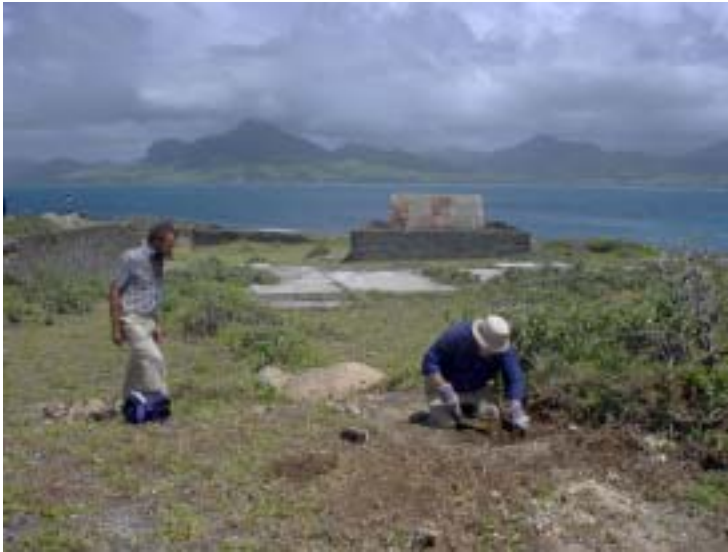
*Zip cleaning sand from part of the Central Platform to reveal features that were unexpected. (03jv1617)*

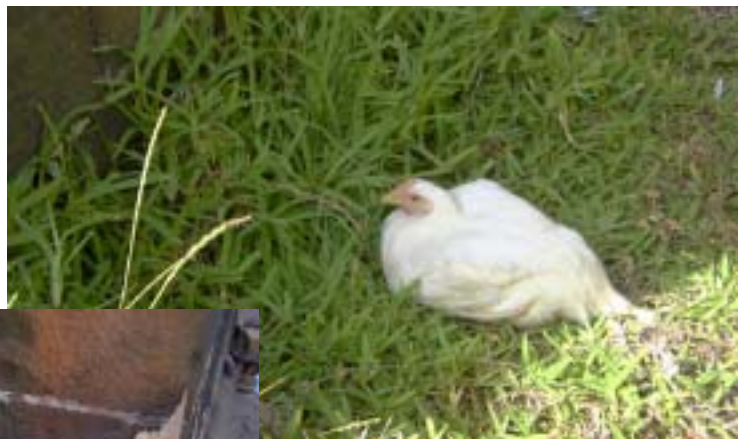
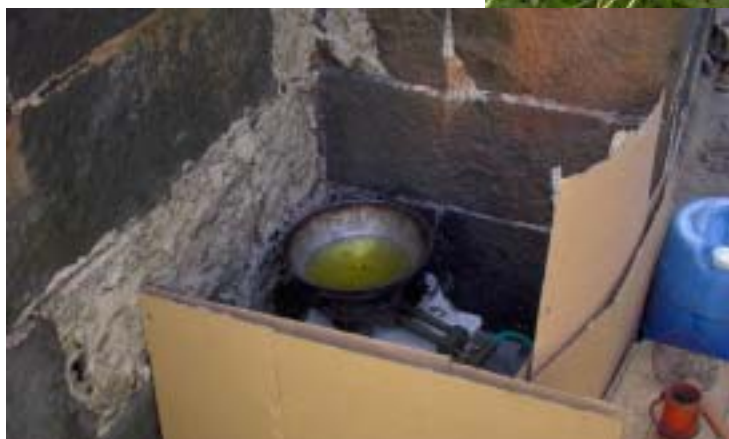
There had been some further damage to standing structures as a result of cooking fires being lit against walls and inside standing structures. While the extent of this damage is not in itself disastrous, the accumulative effect is considerable and, if not halted, will result in the loss of graffiti, some of which have considerable historical importance for Mauritius. Besides this loss, fire damaged wall faces will be both difficult and expensive to repair.

*Damage is not done by the  
unexpected visitor.....  
(03jv1914)*

*But because of its unfortunate  
fate! (03jv1913)*

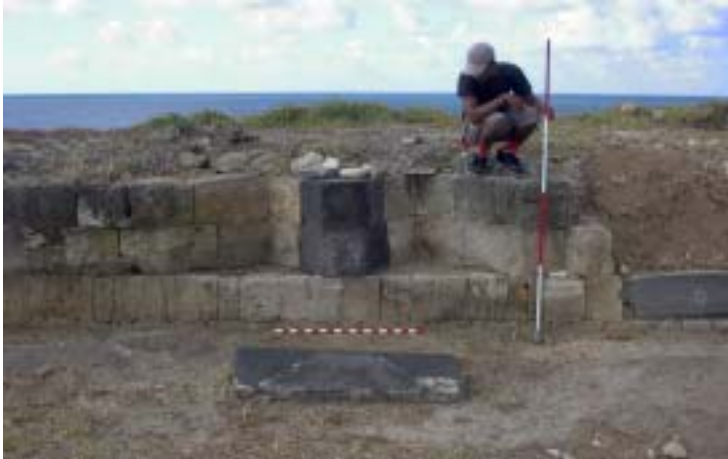
*Some of the basalt stones were put back in place and where necessary a lime mortar, similar to the original one, was used. (03jv3510)*

In general Emplacements 1 and 2 have been partially restored and consolidated as well as the intervening and adjacent stretches of the parapet wall. Fallen stones have been set back in their original positions in the very few cases where it was obvious from whence they had fallen. Otherwise stones were selected and set in a way that mimicked as nearly as possible the original character of the wall. At the Emplacements new stones had to be cut for the angles, and indeed occasionally for elsewhere. This was done with a simple wood saw. Newly cut stone is, however, gleaming white. Experiments with ways of artificially ageing the newly cut surfaces are in hand. The length of time taken by the natural processes that make the cut coral stone grey is not known but it is of interest that when new the battery walls, and the stone buildings, would have been gleaming white.

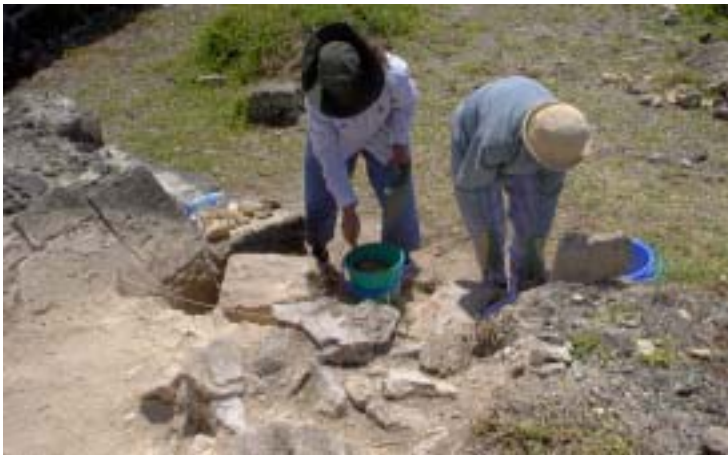
*An exciting discovery was the sloping end of what might be a flagpole base seen in early French maps. (03jv1618)*

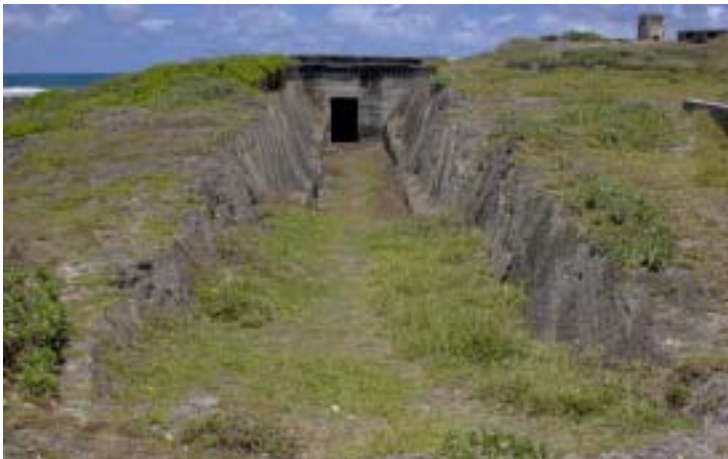
*The enigmatic ditch and newly revealed graffiti were documented after vegetation had been cut back. (03jv2908)*

Vegetation was cut back along both sides of the ditch so as to expose fully all of the graffiti that were hidden from view. In addition the channels and their stepped terminations were partially cleaned. It was decided to strike a balance between the total removal of rather attractive vegetation and the more usual archaeological practice of total cleaning for the sake of clear and complete photographs. Yet another factor in the decision to leave most of the vegetation along the top eastern side of this feature was the barrier that it provided against accidentally stumbling into the Ditch.

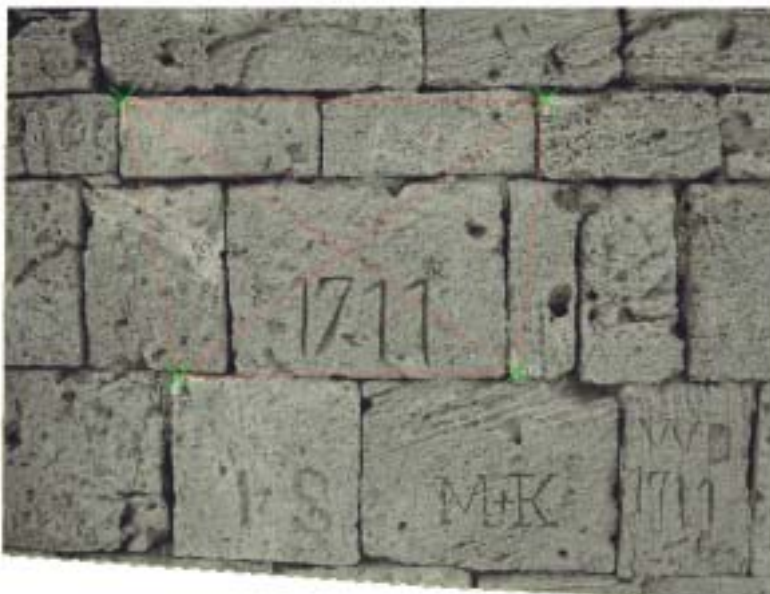
*Rectified digital photo imported in AutoCAD to match control points.*
